# The Performance of Two Dutch Flat Roof Constructions in the Event of a Fire in a PV System

A White Paper

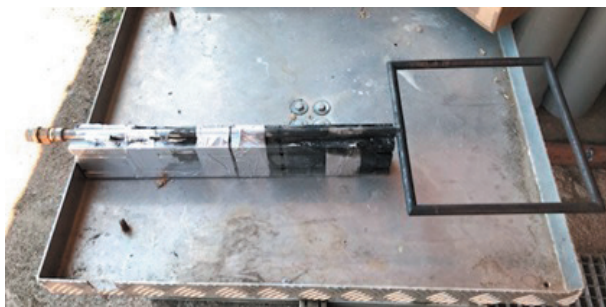
Dimensions and design of the gas burner (upper image from CLC/TR 50670: 2016)

The 15 kW gas burner as described in CLC/TR 50670: 2016<sup>[2]</sup> was chosen and is shown below. The burner was ignited only for enough time to ignite the PV panel under which it was located, rather than the 10 minutes of exposure in the CLC/TR 50670: 2016 test. 3 minutes was chosen because of the quick fire development within the PV array that was tested.

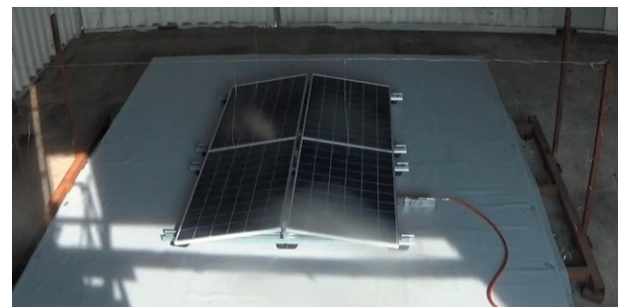
General positioning of the gas burner

The burner was positioned below one PV panel, in the centre of its width, as shown below. This is the identical arrangement as used in CLC/TR 50670: 2016.

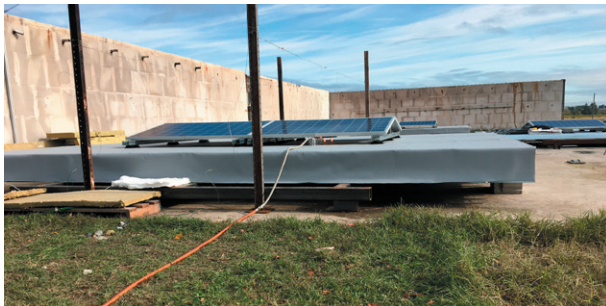
Round 1: Test 1 - Rock Mineral Fibre

The choice of PV panel under which the burner was located was based on the wind direction at the time of the test, such that the burner was placed on the “up-wind” side of the PV array, so that the fire would spread to the whole PV array. The panel under which the burner was located is shown in red in the diagrams below. The wind direction in the outdoor tests is shown with a white arrow. In the indoor tests, any wind came from the door direction.

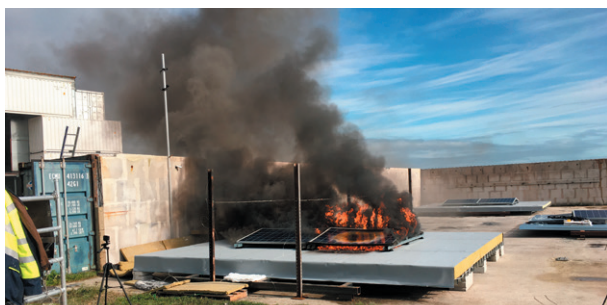
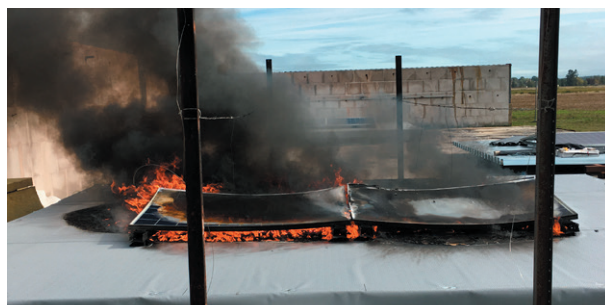
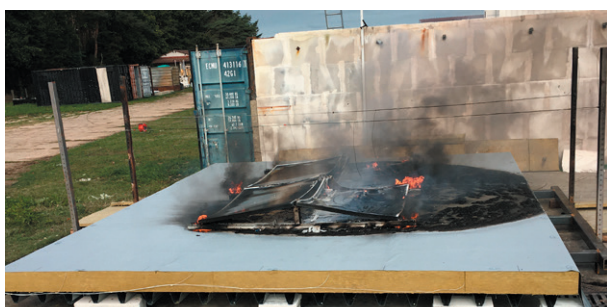
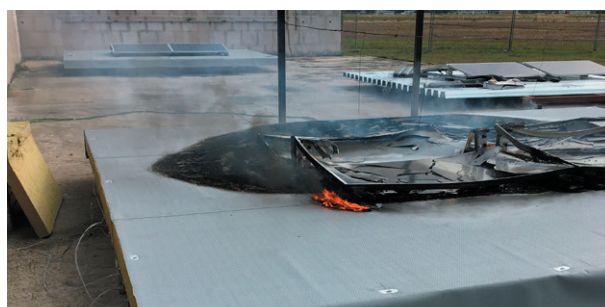
The progress of the fire is illustrated in the images below. The times shown are the elapsed time after burner ignition.

4 mins 49 secs

8 mins 49 secs

12 mins 49 secs

19 mins 39 secs

After test

The burnt surface reached the edge of the roof assembly and the extent was around 4600 x 3540 mm. It is noticeable that there was some impact from wind pushing the fire to one side, and causing an asymmetrical pattern of damage to the membrane.

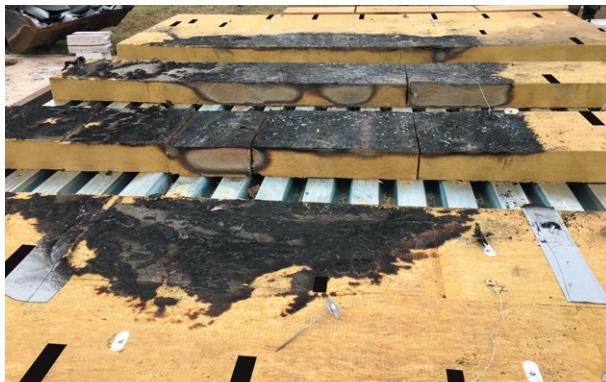
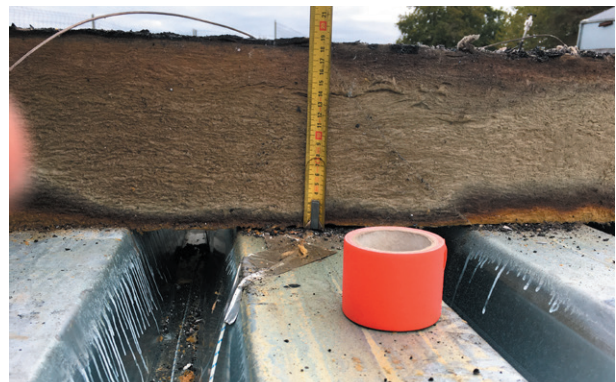
7 hrs 10 mins after burner ignition, smoke was still being released, but there was no visible flaming. The remains of the PVC membrane were removed and the insulation was cut open in cross section to see the pattern of damage. There was an area of shallow damage (binder loss) to the insulation, co-incident with the area of damage to the waterproofing membrane. However, in some areas, localised ovoid patterns of damage penetrated the complete thickness of the insulation.

Given the observation that the temperatures between the steel deck and insulation had risen after the burn-out of the PV array but that no flaming was visible, it seems most likely that this pattern of damage was caused by ongoing smouldering combustion, seeded by heat from the combustion of the PV array.

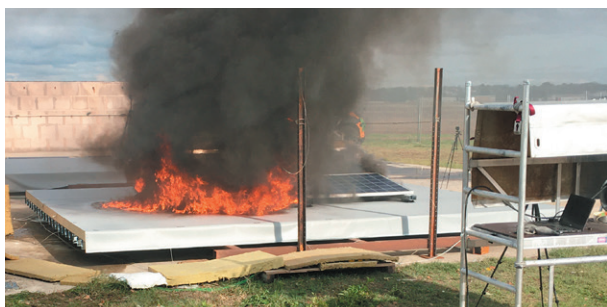
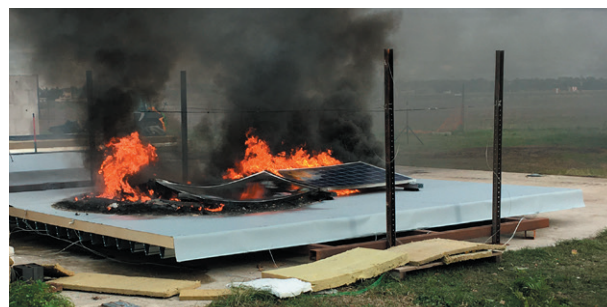
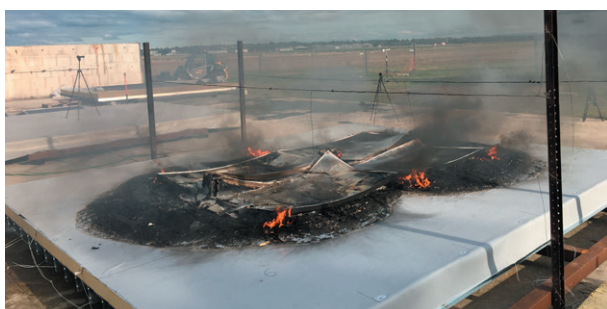
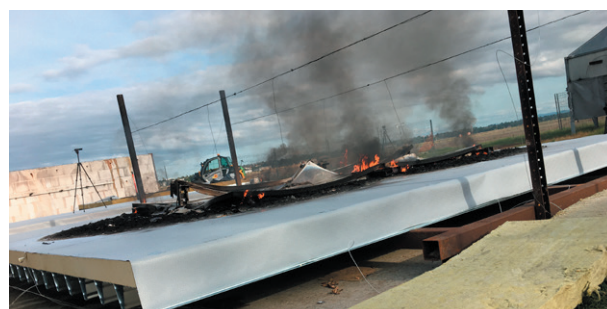
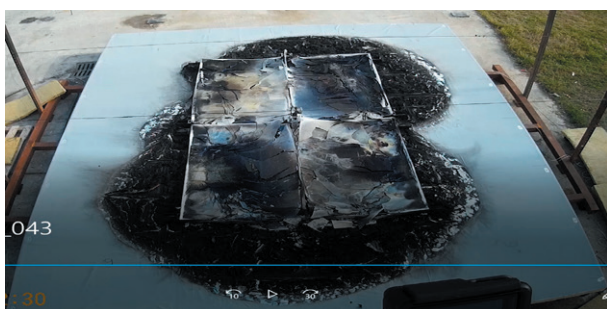
The progress of the fire is illustrated in the images below. The times shown are the elapsed time after burner ignition.

4 mins 22 secs

8 mins 42 secs

14 mins 47 secs

18 mins 02 secs

After test

The burnt surface did not reach the edge of the roof assembly and the extent was around 3300 x 5260 mm. It is clear that there was some impact from the wind in wind pushing the fire to one end, and causing an asymmetrical pattern of damage to the membrane, but, despite the higher measured wind speed, far less than in the test of the build-up insulated with the rock mineral fibre product. This disparity between wind speed and its impact may have been caused by sheltering afforded by local obstacles. The visible fire ceased

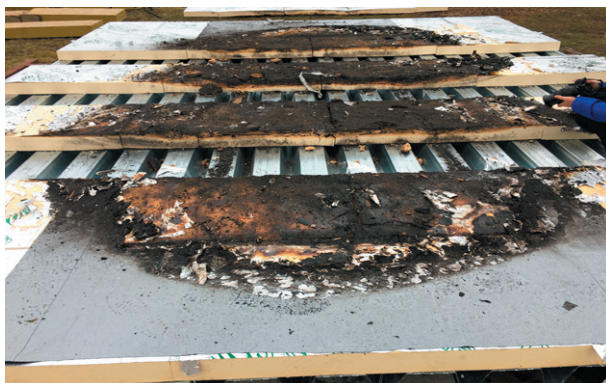
Approximately 18 hrs after fire ignition, the remains of the PVC membrane were removed and the insulation was cut open in cross section to see the pattern of damage. There was an area of combustion/heat damage (charring through to discolouration) to the insulation, co-incident with the area of

damage to the waterproofing membrane. This damage was roughly lens-shaped, and in some discrete locations the damage penetrated 70% of the thickness of the insulation. There was no evidence of localised continuing smouldering combustion processes

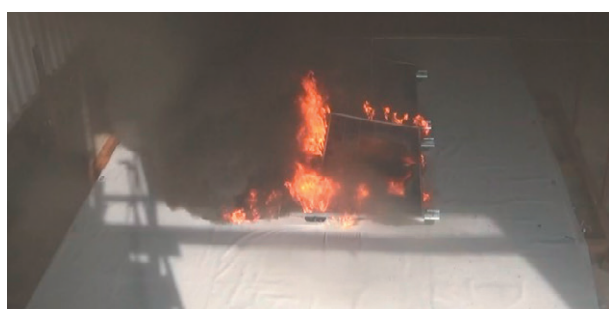
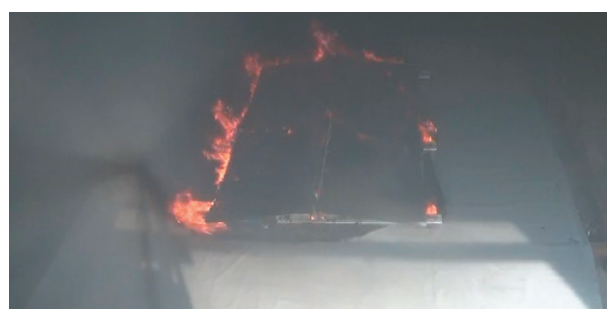
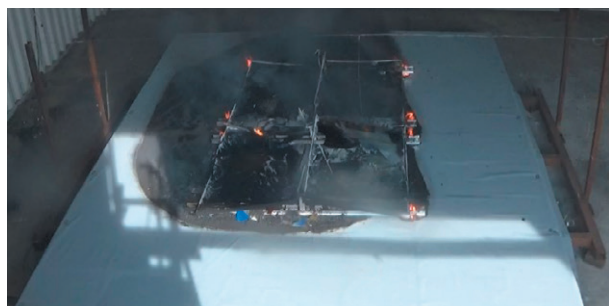
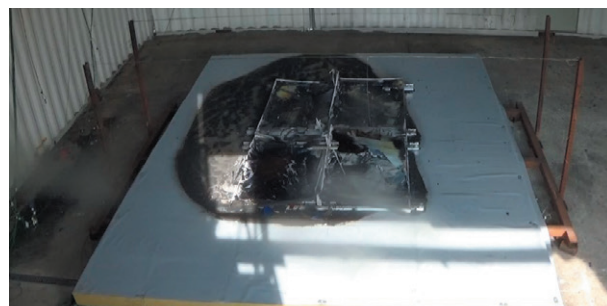
Indoors. The progress of the fire is illustrated in the images below. The times shown are the elapsed time after burner ignition.

4 mins 27 secs

8 mins 27 secs

14 mins 57 secs

The burnt surface did not reach the edge of the roof assembly and the extent was around 3120 x 4790 mm. It is clear that because of the open door to the building in which the tests were conducted, there was some impact from the wind, entering through the door, pushing the fire to one corner, and causing an asymmetrical pattern of damage to the membrane, but less so than in the indoor test of the build-up insulated with Therma™ TR26. Despite the visible fire

After test

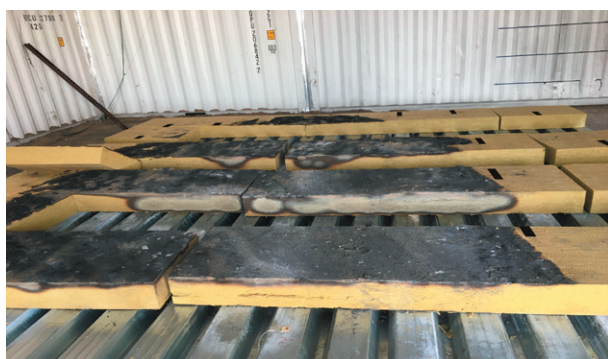
About 4 hrs 20 mins after burner ignition and after removal of the PV system, the damaged surface was measured. About 90mins later, partial dismounting of the flat roof assembly was completed and then the thermocouples within the roof were disconnected. The thermocouples were disconnected when the temperatures recorded by all thermocouples had dropped from their peaks and plateaued. The remains of the PVC membrane were removed and the insulation was cut open in cross section to see the pattern of damage. There was an area of shallow damage (binder loss) to the insulation,

co-incident with the area of damage to the waterproofing membrane. However, in some areas, localized ovoid patterns of damage penetrated the complete thickness of the insulation. Given the observation that the temperatures between the steel deck and insulation had risen after the burn-out of the PV array but that no flaming was visible, it seems most likely that this pattern of damage was caused by ongoing smouldering combustion, seeded by heat from the combustion of the PV array.

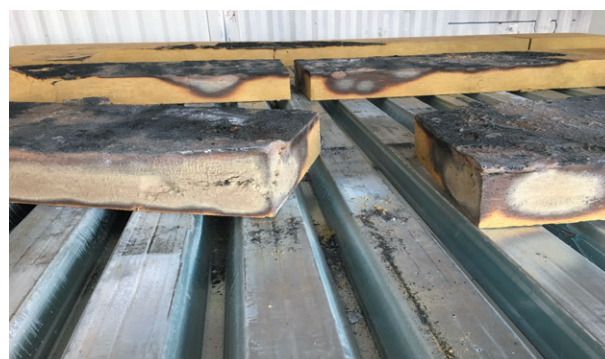
The day after the test, because they appeared to remain hot, a thermocouple was inserted inside the dismantled

rock mineral fibre boards that had been stored outside, and temperatures up to 760°C were recorded.

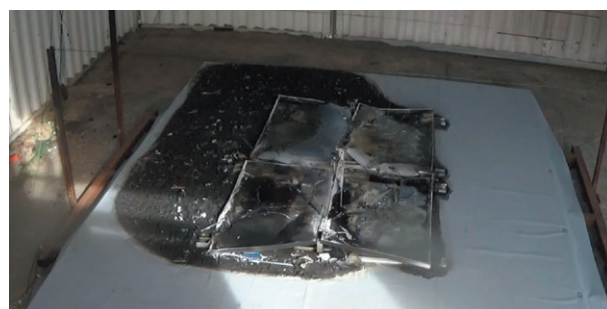
After test

The burnt surface reached the edge of the roof assembly and the extent was around 3430 x 4800 mm. It is noticeable that, despite largely closing the door to the building in which the tests were conducted, there was somewhat more impact from the wind, entering through the door, pushing the fire to one corner, and causing an asymmetrical pattern of damage to the membrane, than with the test of build-up insulated

with the rock mineral fibre product. The visible fire ceased at around 43 mins after burner ignition. The temperature between steel deck and insulation peaked at under 31°C in one thermocouple location at around 31 mins after burner ignition before dropping (see following page). These observations suggest that no continuing smouldering combustion was taking place within the roof system.

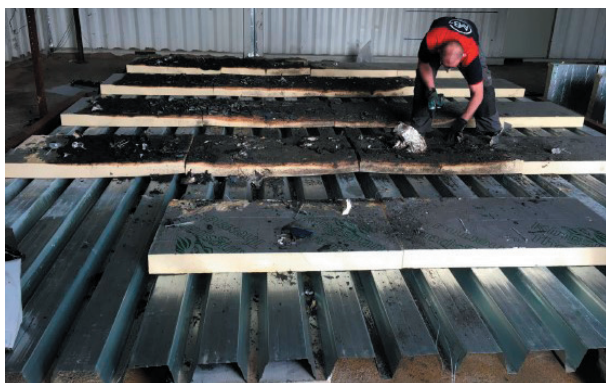
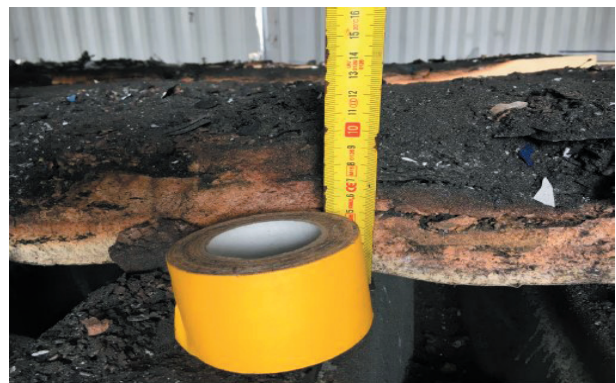
About 1hr 40mins after burner ignition and after removal of the PV system, the damaged surface was measured. About 10mins later, partial dismounting of the flat roof assembly was completed and then the thermocouples within the roof were disconnected. The thermocouples were disconnected when the temperatures recorded by all thermocouples had dropped from their peaks and plateaued. The remains of the PVC membrane were removed and the insulation was cut

open in cross section to see the pattern of damage. There was an area of combustion/heat damage (charring through to discolouration) to the insulation, co-incident with the area of damage to the waterproofing membrane. This damage was roughly lens-shaped, and in some discrete locations the damage penetrated 90% of the thickness of the insulation. There was no evidence of localised continuing smouldering combustion processes.
